DETERIORATION OF SYNTHETIC FIBER ROPE
DURING MARINE USAGE

PROGRESS REPORT PROJECT R/T-11
PERIOD JANUARY 1 - DECEMBER 31, 1981

PREPARED FOR
SEA GRANT OFFICE
MASSACHUSETTS INSTITUTE OF TECHNOLOGY
CAMBRIDGE, MASSACHUSETTS 02139

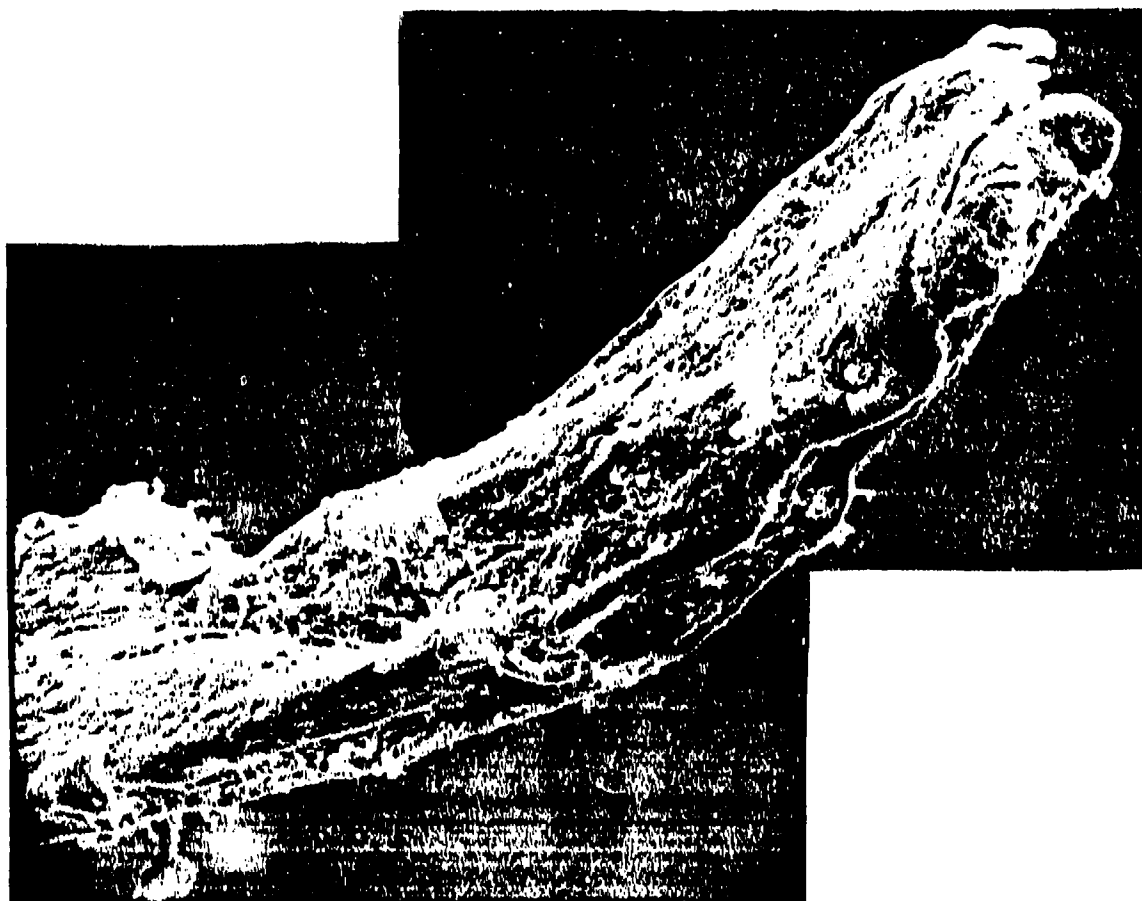
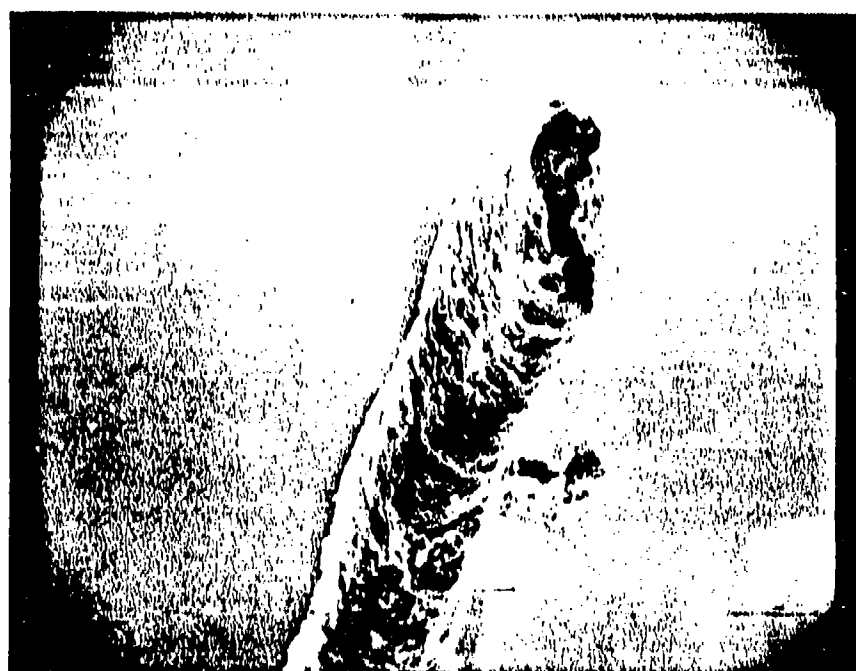
FIG. 3.37D,E DISINTEGRATED FIBER ENDS FROM WORN ROPES

Microscopic studies of the ten worn rope specimens have documented the various types of degradation which occur during marine usage of synthetic fiber lines. The appearance of filaments at the outermost location of the 3-strand twisted rope varies from strand to strand, sometimes manifesting an encrustation and coating, or surface attack. Etching is seen in some fibers leading to a porous spongy structure. Surface gouging, abrasion, and/or filament crushing are frequently in evidence. In many cases, photomicrographs are accompanied by filament load-elongation curves, to permit a subjective correlation between the extent of filament-surface encrustation or other non-mechanical filament modifications and stress/strain behavior. Fractography studies show a marked conversion in surface-exposed filaments from the scallop-shaped crack spreading-failure of a new synthetic fiber to the cup and cone, sheath/core, longitudinal splitting and occasional brittle failure characteristic of chemically or photochemically degraded fibers.

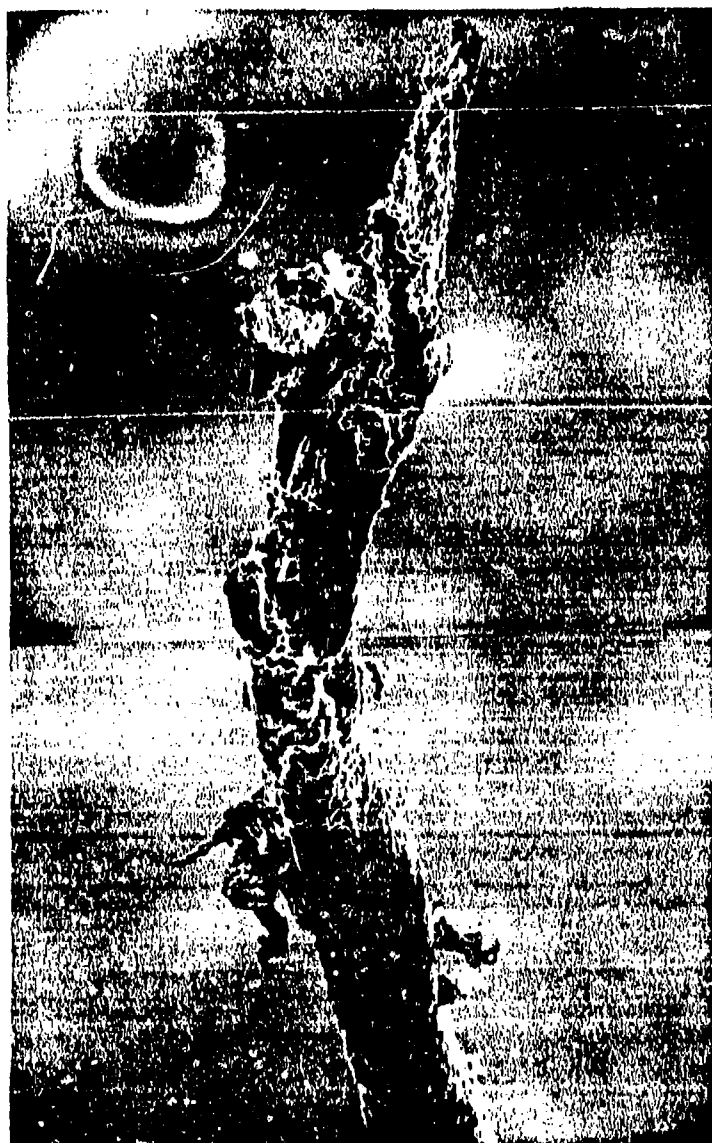
FIG. 3.37G DISINTEGRATED FIBER ENDS FROM WORN ROPES

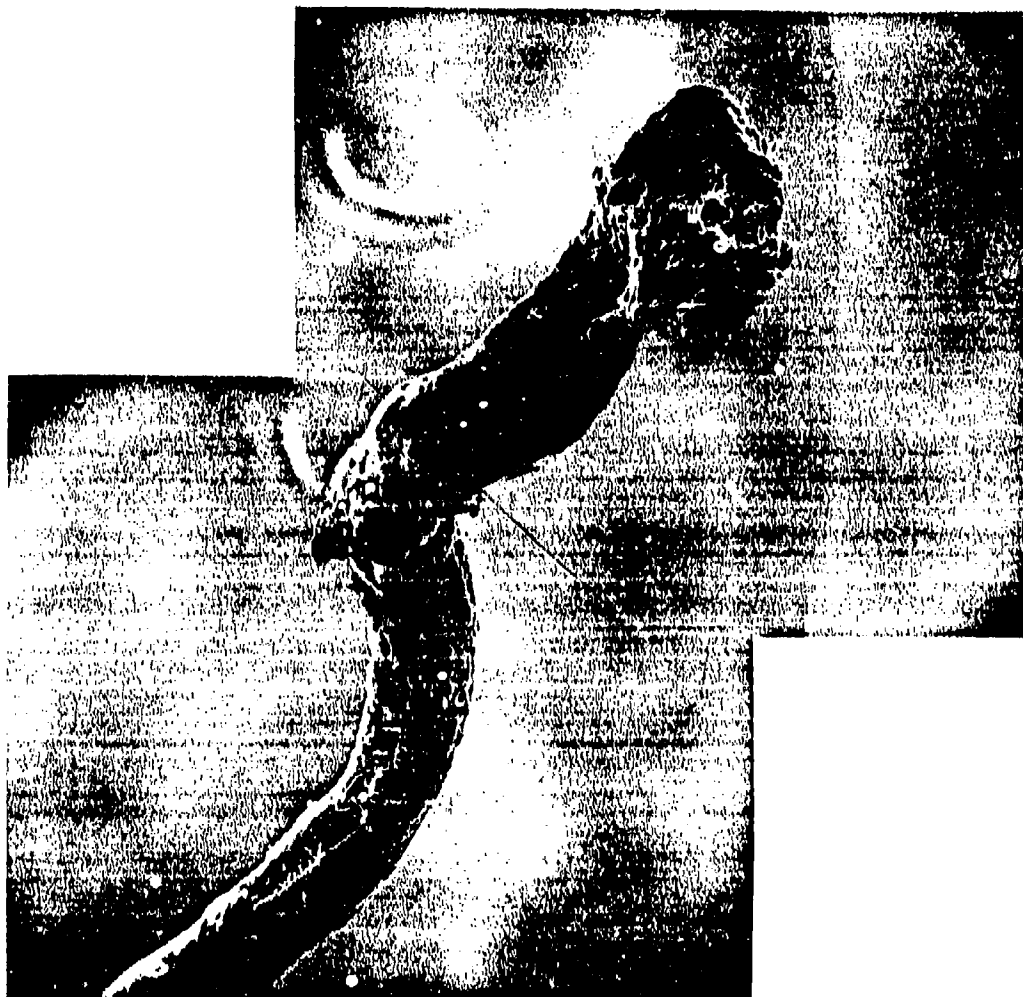
FIG. 3.37H DISINTEGRATED FIBER ENDS FROM WORN ROPES

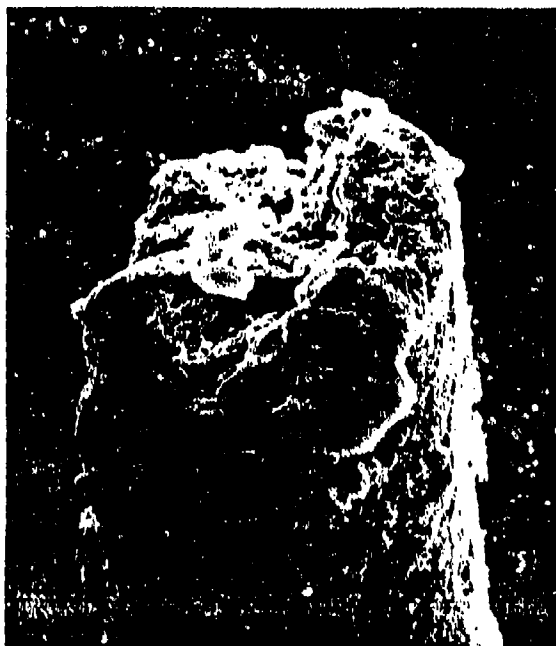
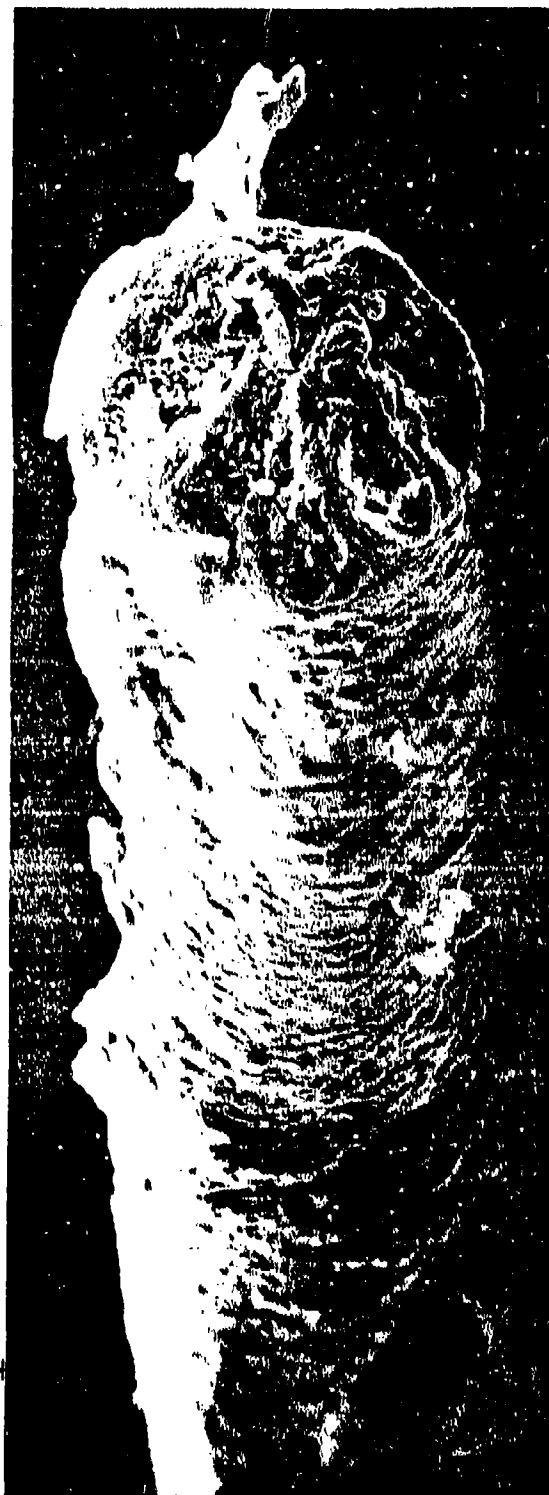
FIG. 3.38A SURFACE LAYER FIBERS FROM THE EXPOSED ZONE OF ROPE #4 (1972)

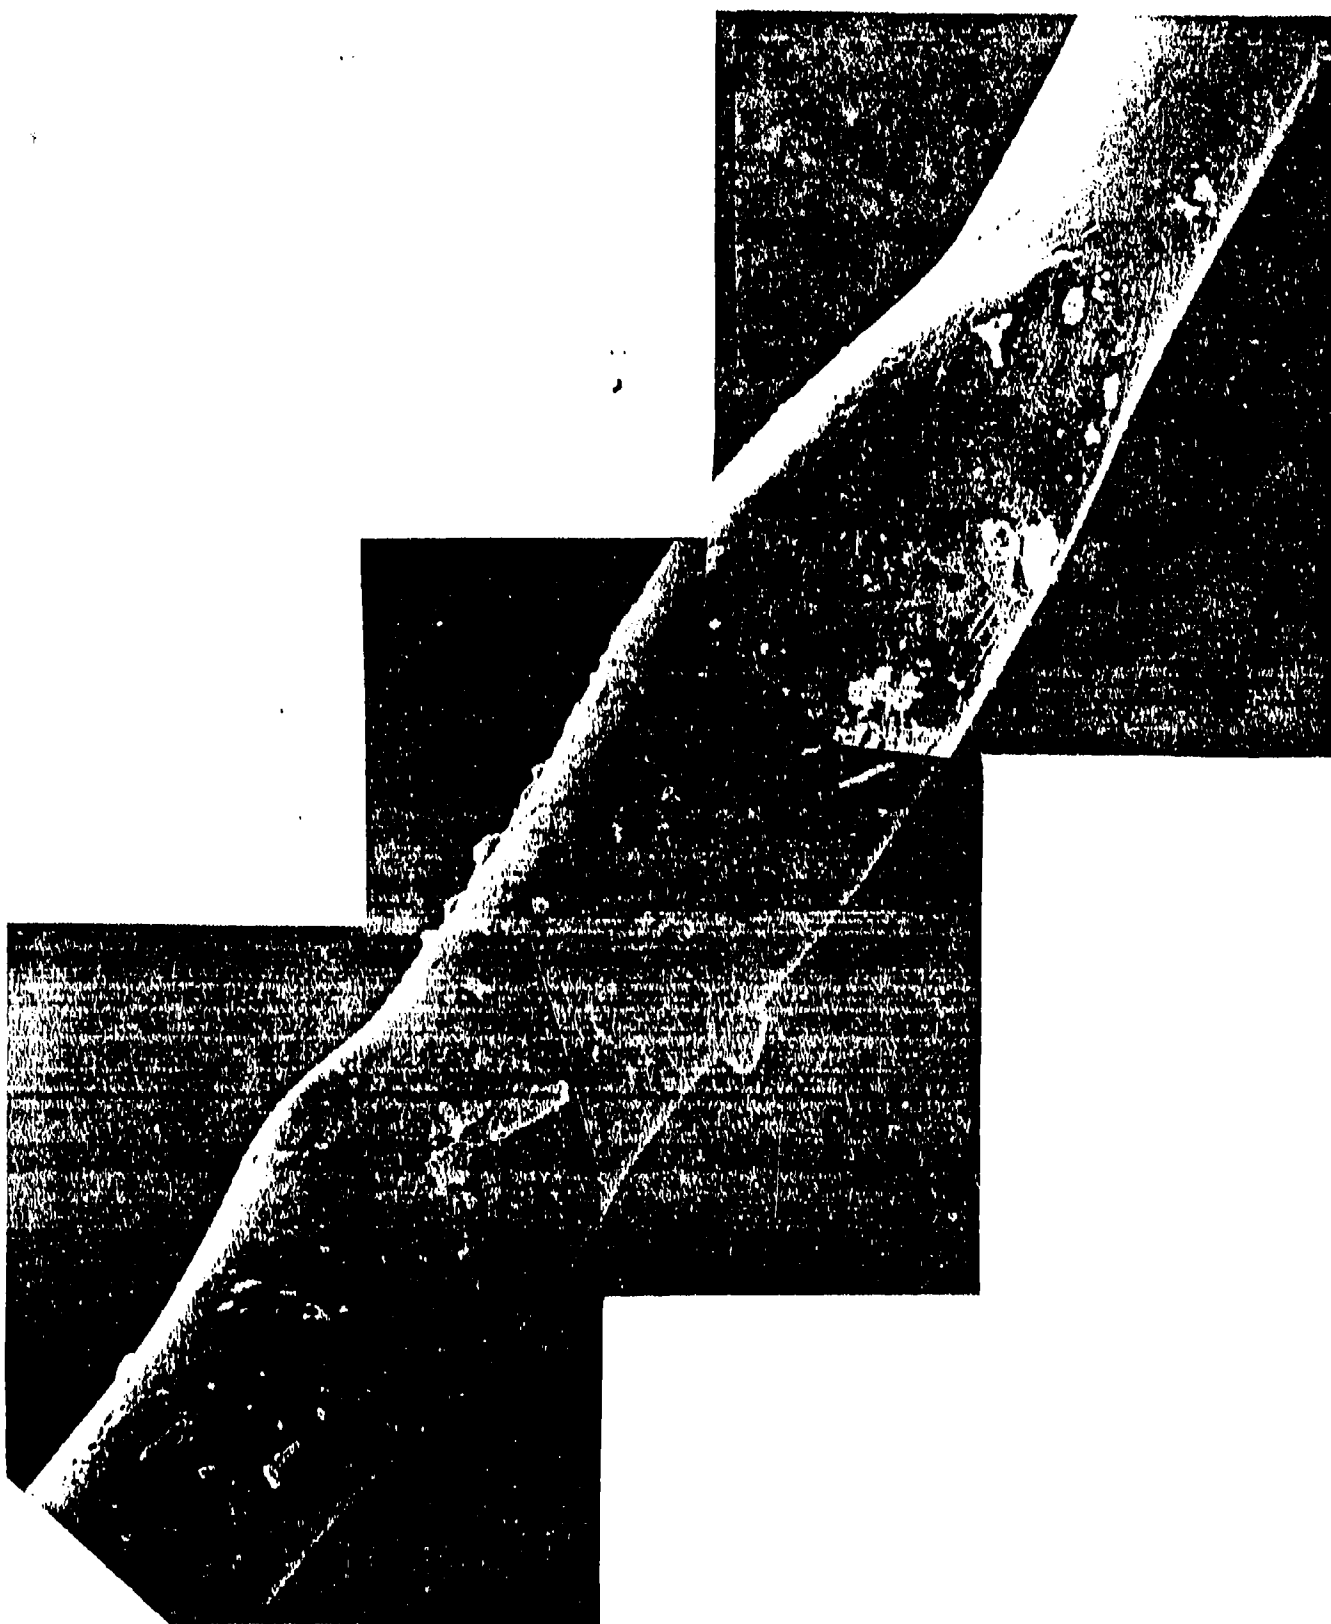
FIG. 3.44A COMPRESSED FILAMENT FROM EXPOSED SURFACE LAYERS OF ROPE #2 (1966)

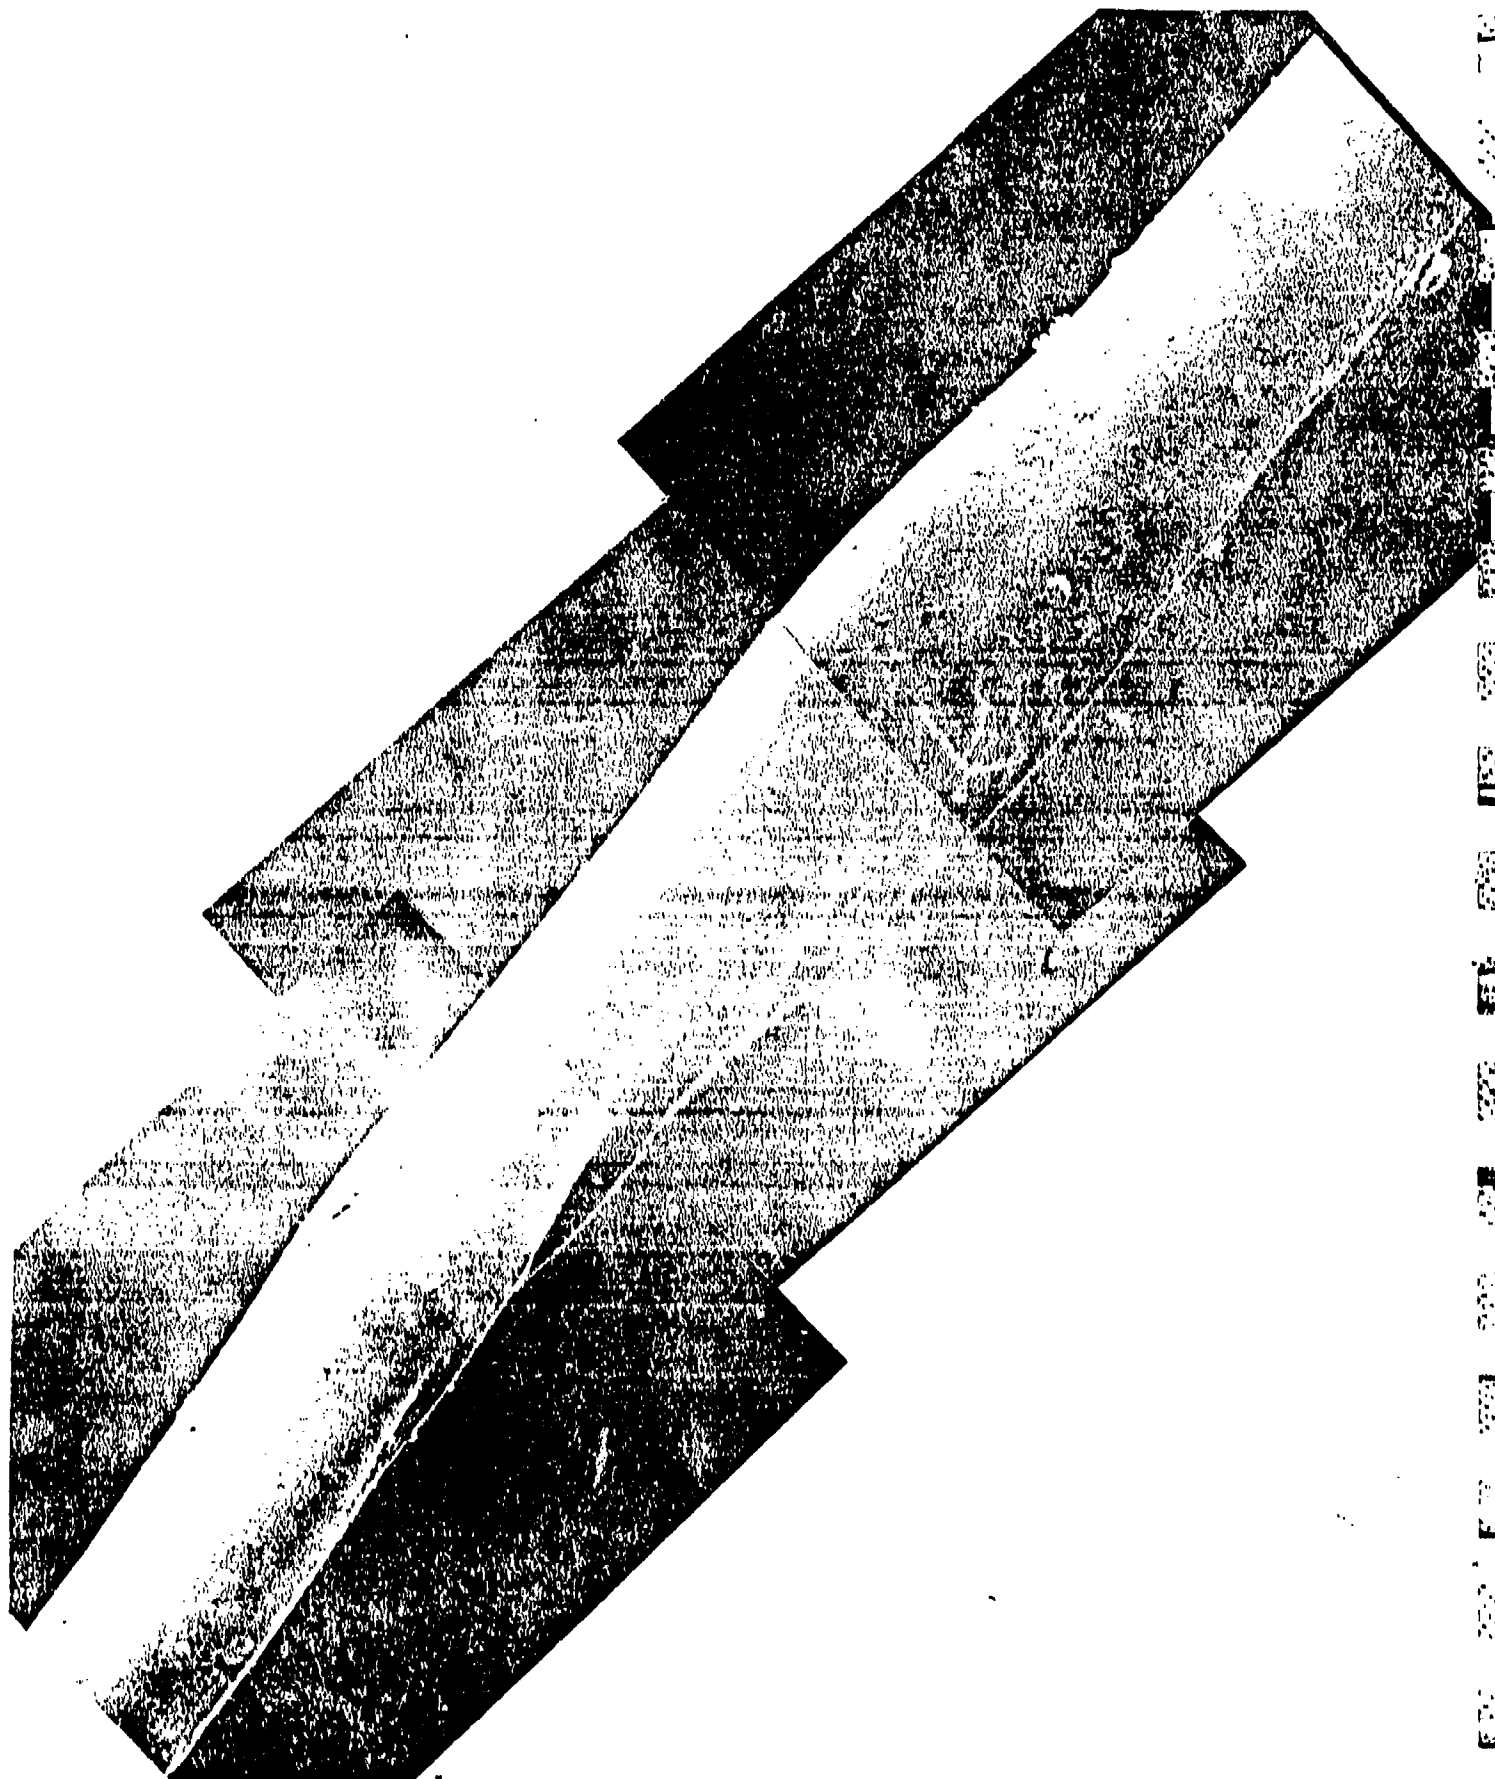
FIG. 3.53 FILAMENT FROM STRAND CORE OF ROPE #2 (1966)

Finally, it is seen that internal pressures within the rope center, i.e. between strands, can be so intense as to cause "welding" of parallel filaments, adding locally to the bending rigidity of the rope and focusing frictional damage to fibers at the boundaries of the "welded" zones. Such pressures often result in lateral filament compression and in locations where filaments are not parallel, to embossing of individual fibers. Such compression/embossing is sometimes accompanied by the opening of surface cracks in the filament and, in extreme cases, to significant reductions in filament strength.

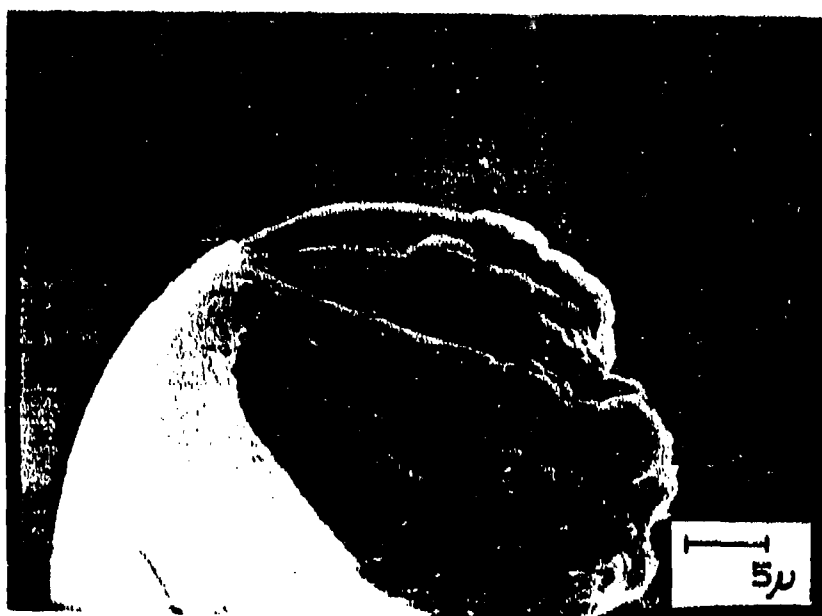
FIGURE 5.19

FATIGUE FRACTURE SURFACE OF SINGLE DRY
FIBER CYCLED AT 90% OF THE ULTIMATE LOAD

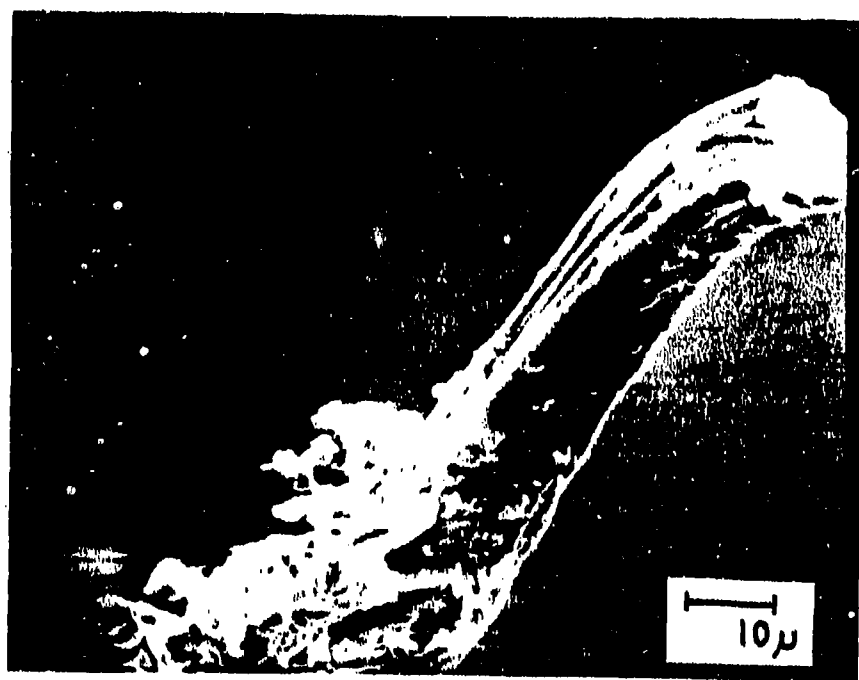
FIGURE 5.20

FATIGUE FRACTURE SURFACE OF FIBER FROM A DRY
YARN CYCLED AT 50% OF THE ULTIMATE LOAD
